**Jorgensen Forge Outfall Site
Seattle, Washington**

**Source Control Action
Completion Report**

Prepared by
FLOYD | SNIDER
601 Union Street
Suite 600
Seattle, Washington 98101

May 27, 2011

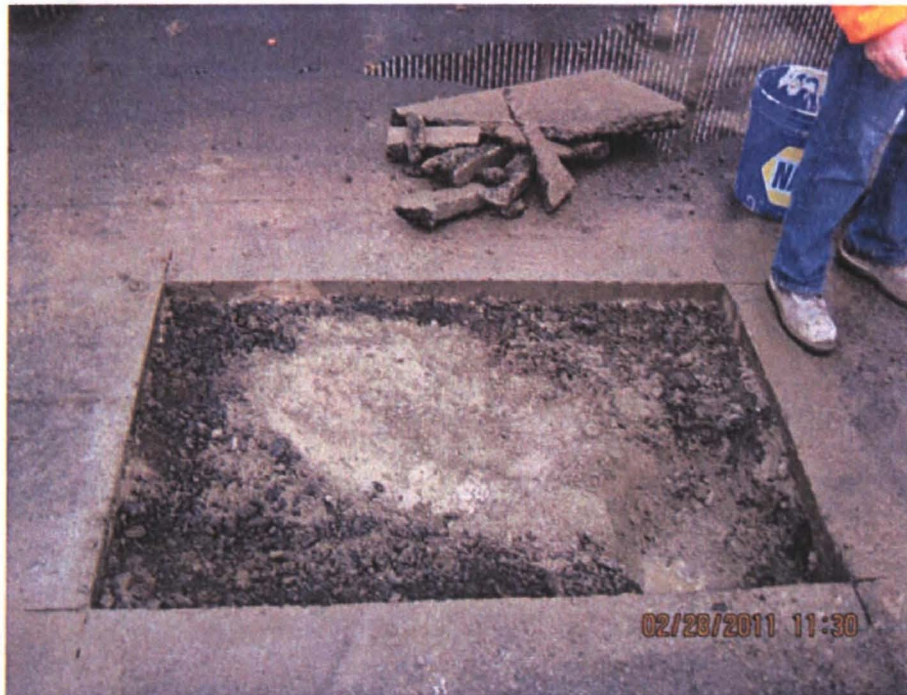
Photo 62. Jorgensen Visitor Parking Area 4-inch Lateral sealed with CDF prior to asphalt patching.
